NASA/TM-2008-215525
NESC-RP-06-61/05-036-E

Failure Analysis Study and Long-Term Reliability of Optical Assemblies with End-Face Damage

**Failure Analysis Study and Long-Term Reliability of Optical
Assemblies with End-Face Damage
Technical Assessment Report**

***Phase I: International Space Station (ISS) Termini Root Cause
Analysis Report***

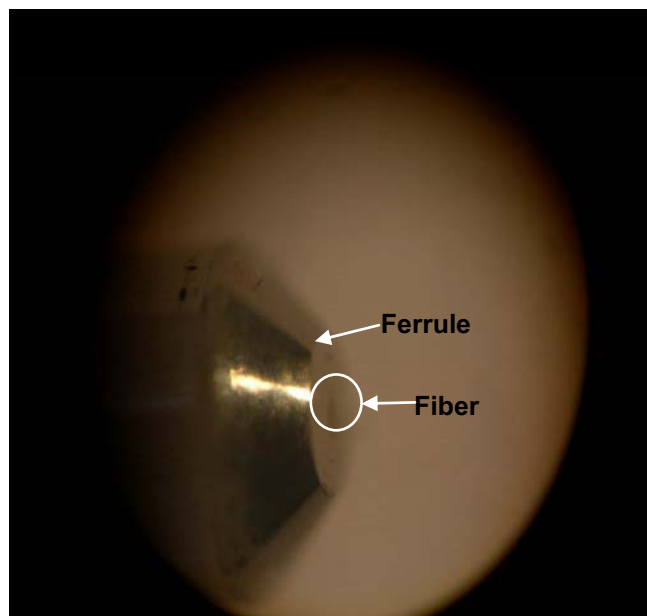
Figure 4.0-1. Visual End-Face Profile @ Magnification of 40X

In many applications, a physical contact connection is implemented to mate fiber optic connectors such that the insertion losses are reduced. In the case of this connector, the high vibration levels originally used to “qualify” the connectors for military standard applications showed data indicating that the terminus/connector system should not be of a physical contact type. Therefore, the same processes were specified in this application. For a “concave” polish, it is imperative that the glass end-faces do not come in contact with one another in order to comply with the military standard method and reasoning for non-contact. As stated in OHB’s “Fibre Optic Manufacturing Procedure” Section 4.6: “Inspect the profile of the terminus end-face under 40X magnification. The surface should be slightly concave with the face of the ceramic tip.” This is not an effective method for determining the fiber’s profile. Figure 4.0-1 shows what the profile looks like at 40X magnification. The end-face appears to be flat, and not protruding. This method is non-conclusive for true determination of the end-face profilometry. The profile should be determined using an interferometer or confocal microscopy as illustrated in Figure 4.0-2. The confocal data clearly shows the end-face of the fiber to be convex, which should have failed inspection.

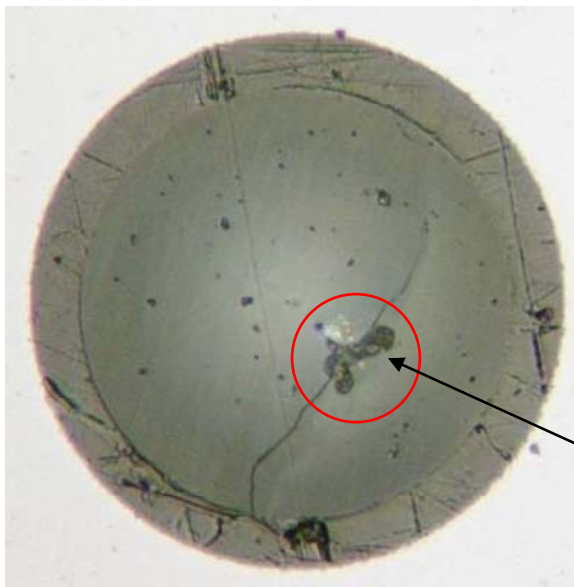
The images in Figures 7.1-1 and 7.1-2 were taken at 200X magnification. The first observations made were: 1) the apparent impact fracture on the end-face, 2) the crack(s) propagating from the fracture, 3) damaged or scarred coating or buffer, and 4) the excessive contamination on the end-face of the fiber.

Impact Fracture/Cracking

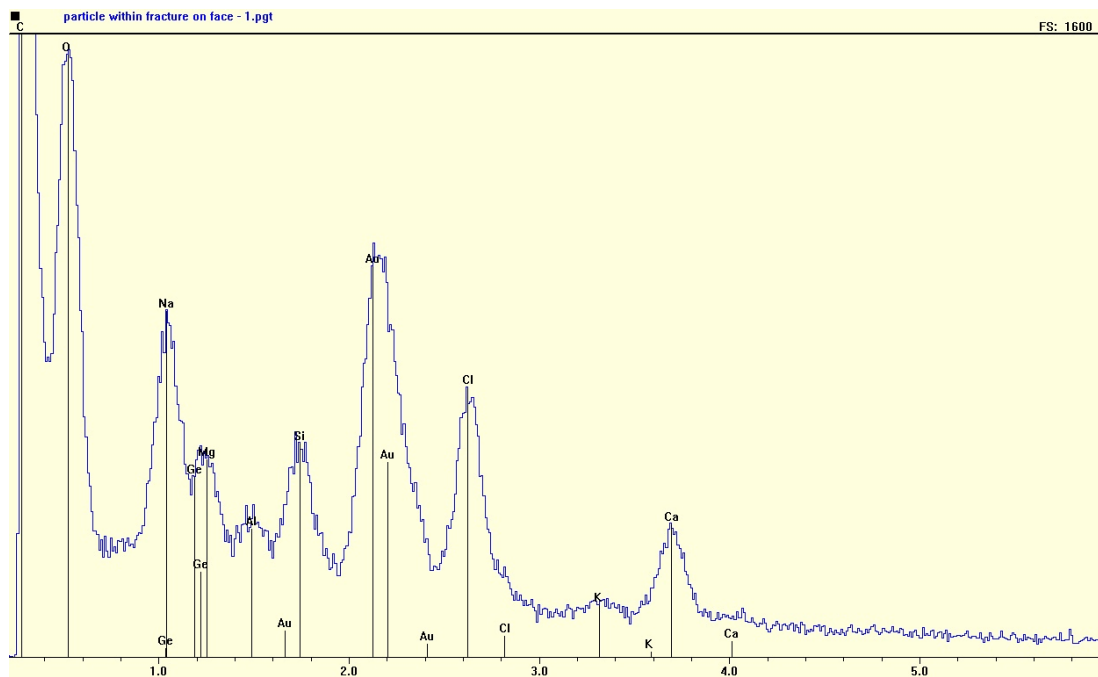
Figure 7.1-5. EDS of Particle inside the Fracture

The discovery of salt crystals in the glass was puzzling. To identify where the salt crystals are located on the end-face, elemental mapping was performed. Elemental mapping was not effective at 500X magnification to locate small traces of certain elements, so to locate Na and Cl, a higher magnification was used. Figure 7.1-6 shows the results when this sample was mapped for Si, Na, and Cl.

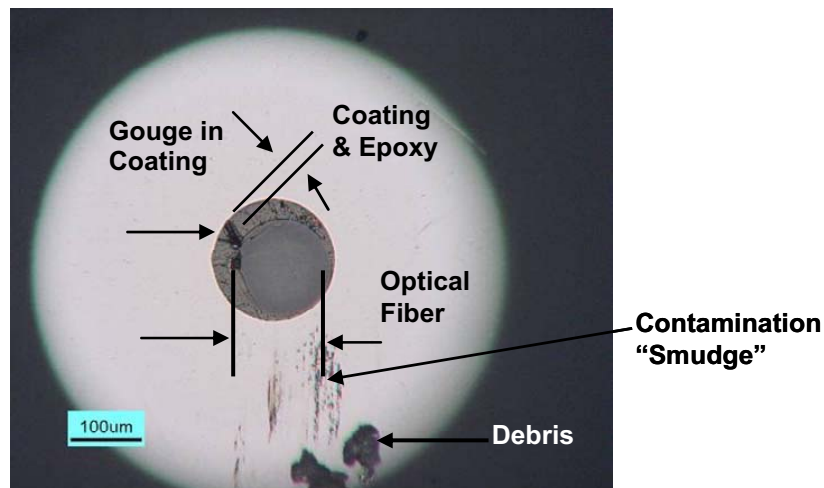
Figure 7.2-1. Magnification of 100X Optical Image

The deep scratches indicate the end-face was “wiped” with something that had an abrasive particle present. It could have been mated with debris present as well.

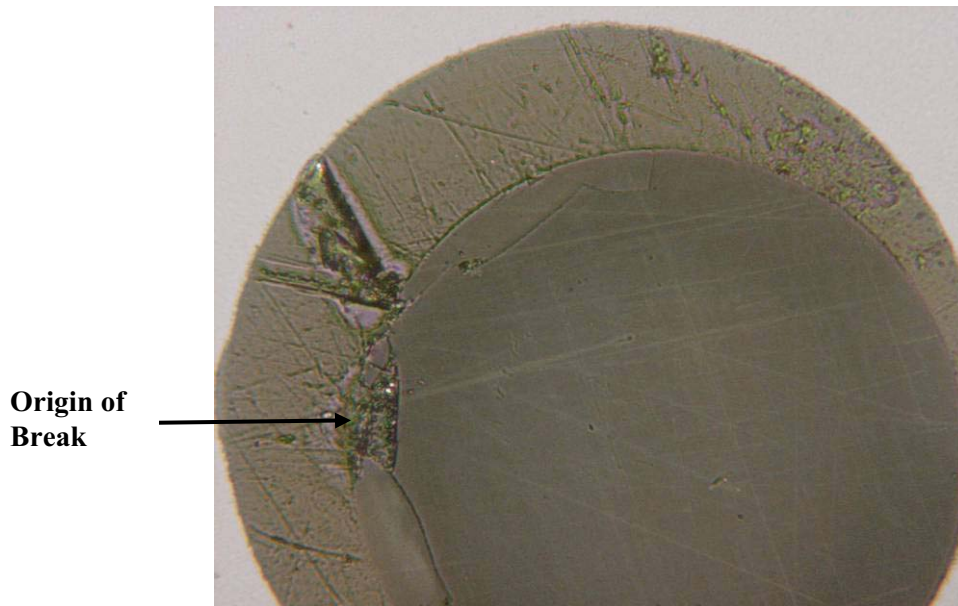
Figure 7.2-3. Deep Gouge in Coating

during the epoxy curing procedure. The non-uniform distribution is due to the non-concentric location of the fiber in the coating.

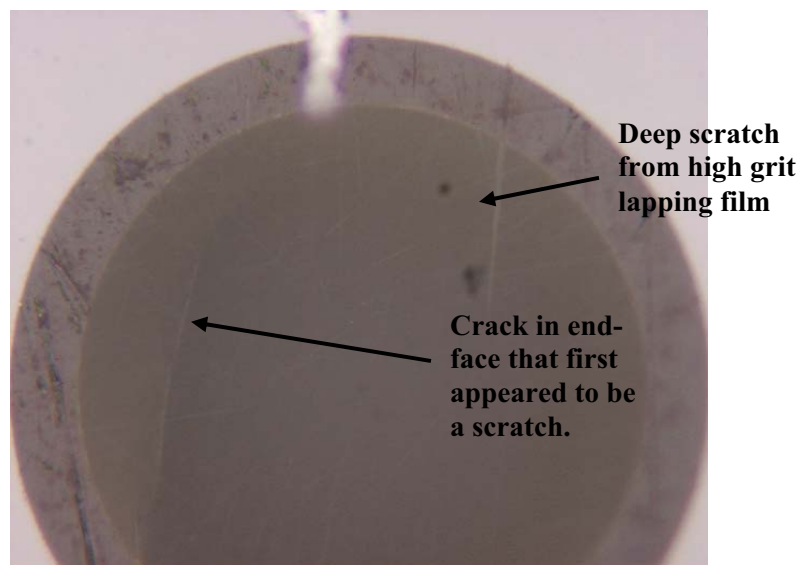
Figure 7.3-1. Scratched/Cracked End-Face

When looking at this fiber at 500X magnification, a deep scratch can be seen. There is also a crack in the fiber that first appeared to be a scratch. This signature of linear scratches is indicative of polishing with high grit lapping film, and not removing the scratches with lesser grit lapping film. Refer to Figure 7.3-1.

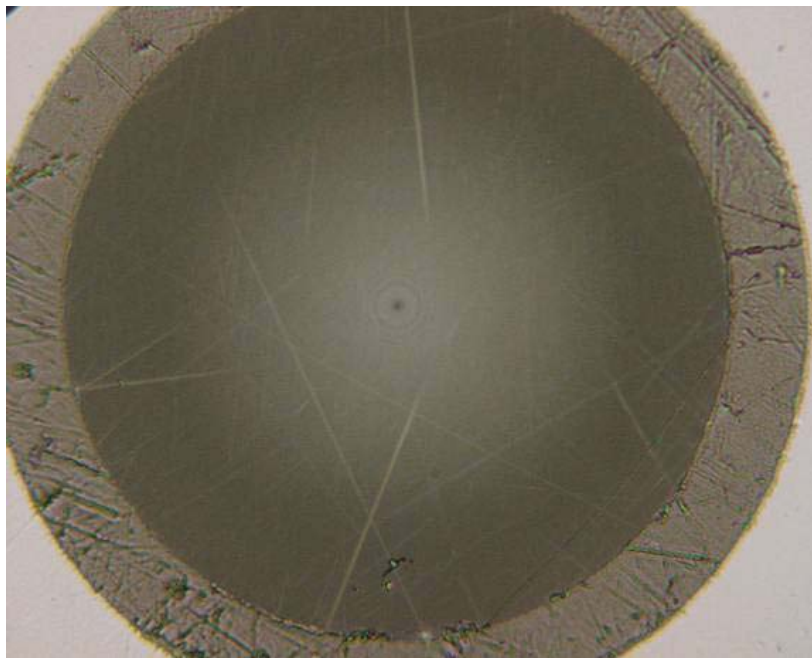
Figure 7.4-1. Bright Field Image Magnification of 500X

At 500X, some deep scratches on the end-face can be observed (Figure 7.4-1). By changing the illumination field settings, a crack in the fiber can be seen (Figure 7.4-2). ***Light will pass through a crack that is $<1/8\lambda$, and the crack will not be visible.*** Some debris on the end-face can also be observed.

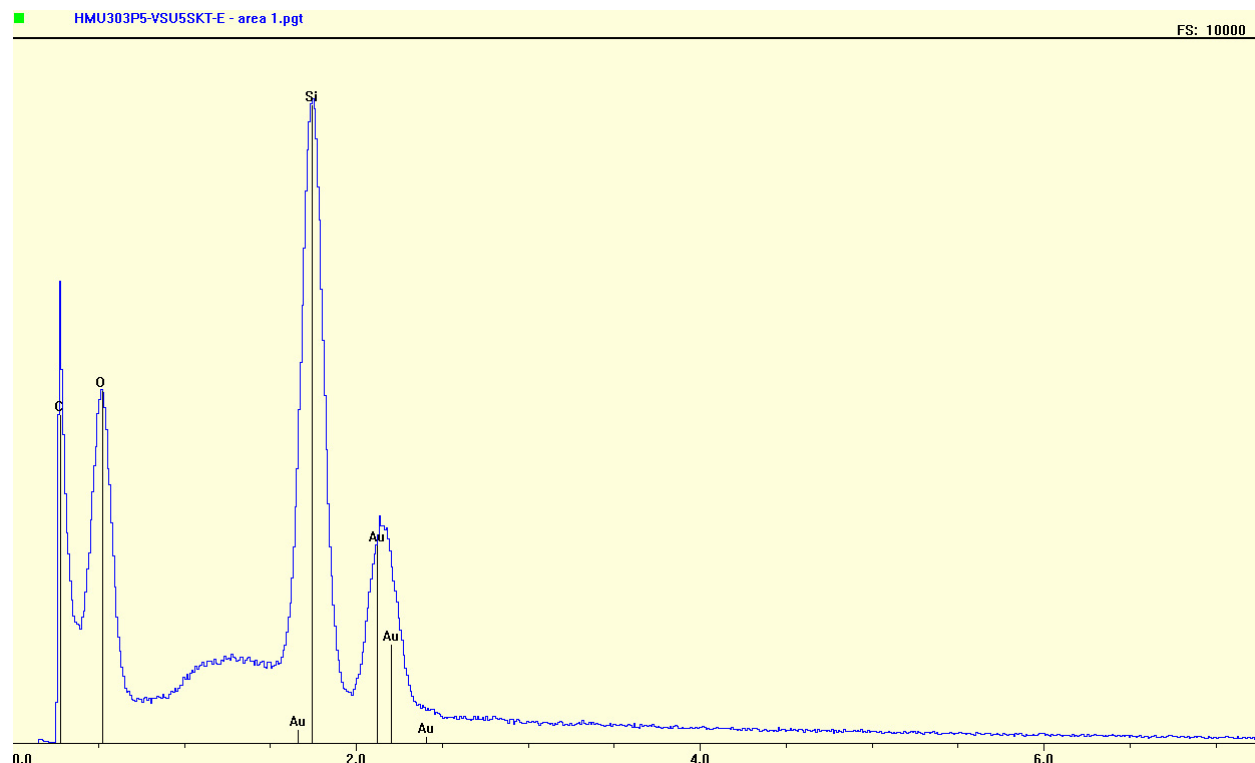
Figure 7.4-5. EDS Data of Crack

An EDS data analysis was performed (Figure 7.4-5) in the crack region to identify any foreign particles, and a high concentration of carbon, oxygen, and silicon was found. This may suggest the grit of the lapping film was too coarse.

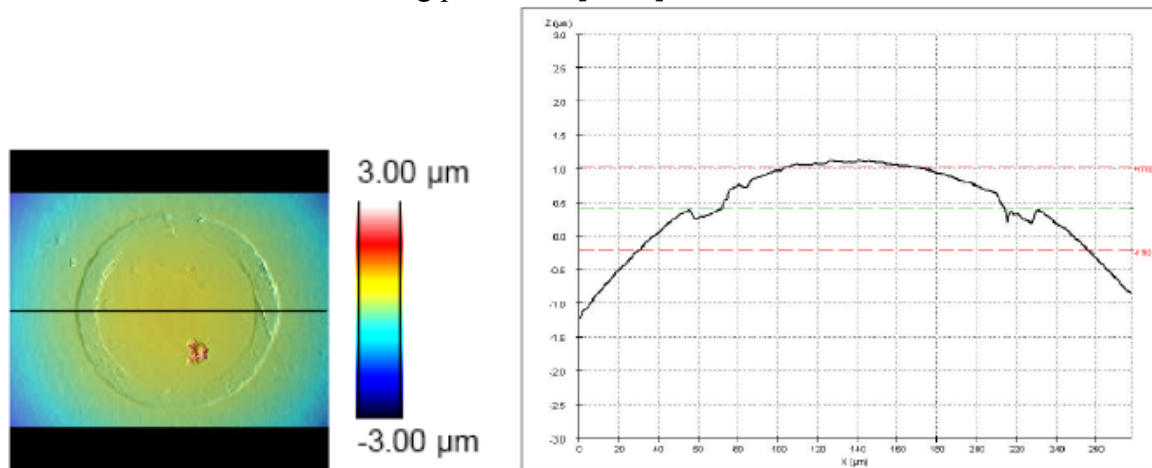
Figure 7.5-10. Confocal Data

The confocal data (Figure 7.5-10) indicates the fiber is convex which, again, violates the requirements stated in the manufacturing procedure [ref. 3]. The radius of curvature is 4.0 mm.

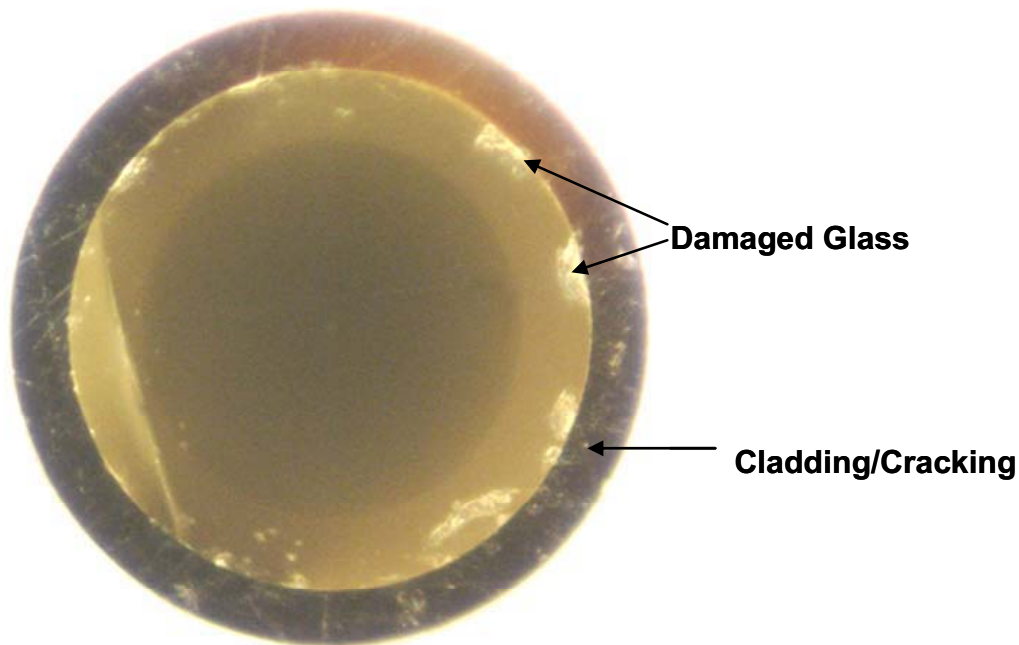
Figure 7.6-1. Magnification of 200X Optical Image

1. There was a crack in the cladding area.
2. There was damage to the glass in several areas around the perimeter of the cladding.

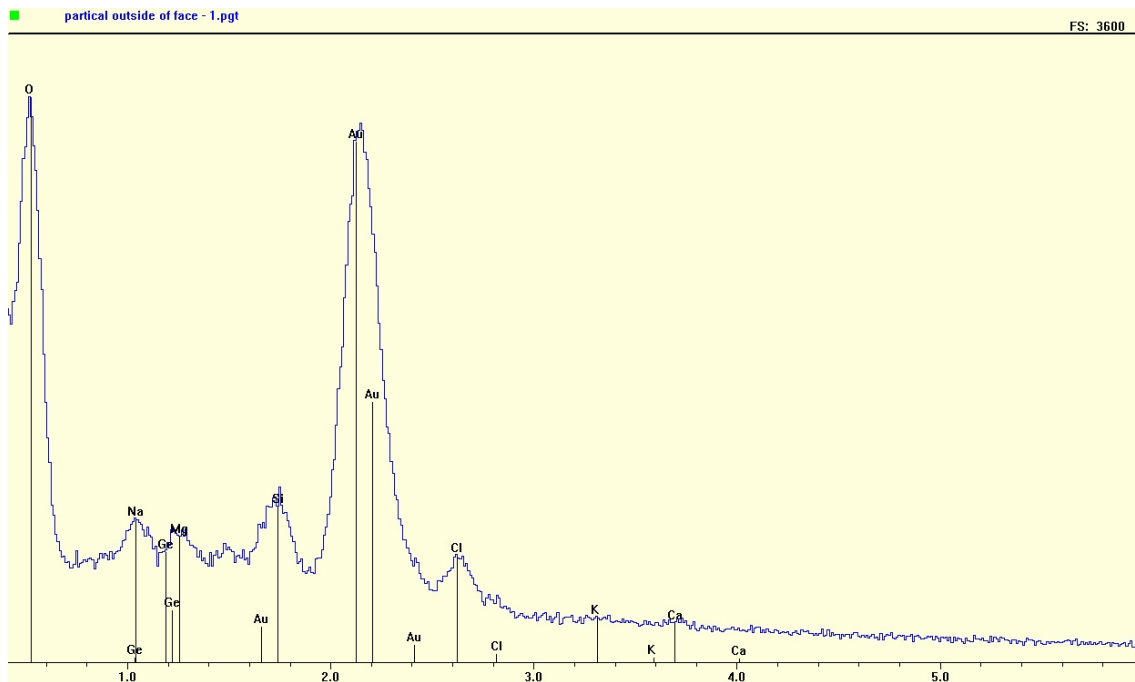
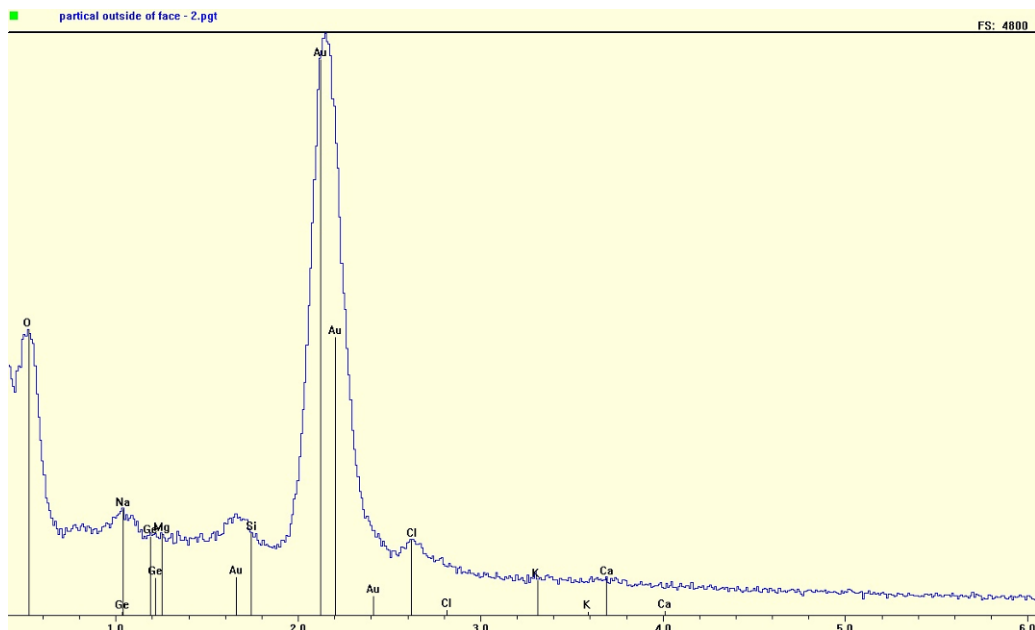
An EDS data analysis (Figure 7.6-5 and Figure 7.6-6) was performed on some debris on the ferrule end-face.

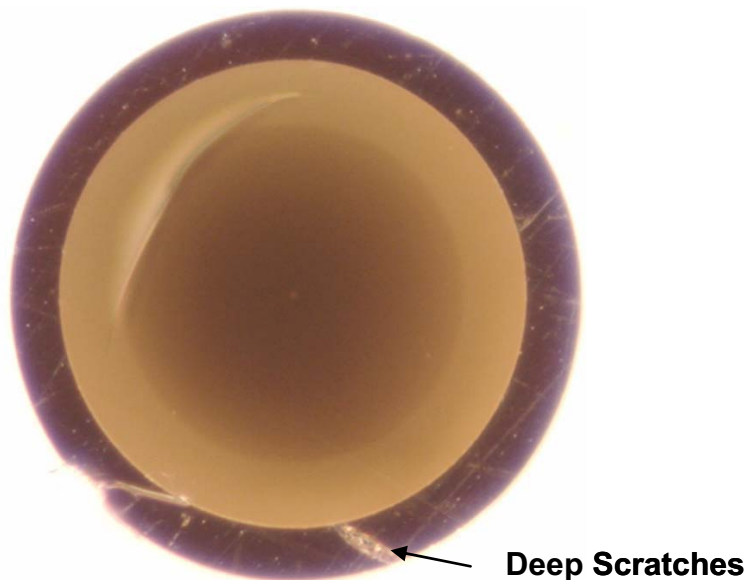
Figure 7.7-1. Dark Field Image @ Magnification of 200X

Figure 7.7-1 shows a deep scratch in the end-face of the fiber. This is not a crack that has propagated deep into the fiber. This is evident from how the light is emitted through the crack. When Figures 7.7-1 to Figure 7.10-2 are compared, how the light is affected by a deep crack is observed. There are two areas in the coating with significant damage as well. The damage in the coating is not linear (like the minor visible scratches), thus suggesting it did not occur due to polishing.

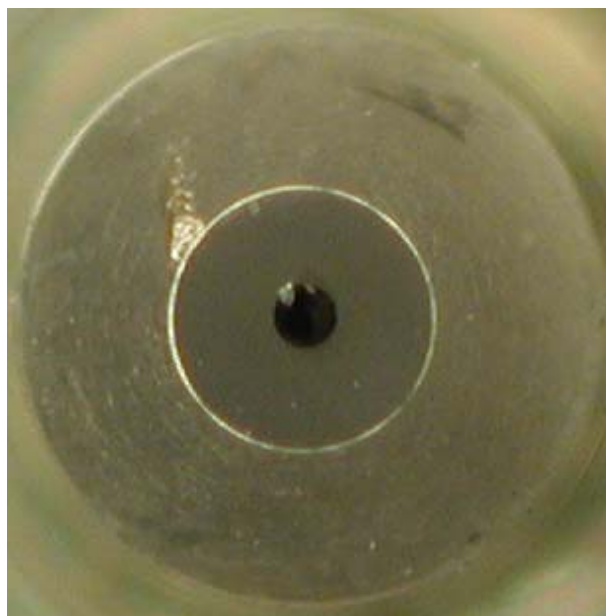
Figure 7.8-1. Optical Image at Magnification of 10X

At 10X magnification (Figure 7.8-1), it is very difficult to identify any possible defects in the fiber. Some debris is present over the fiber area and would appear to only need a cleaning.

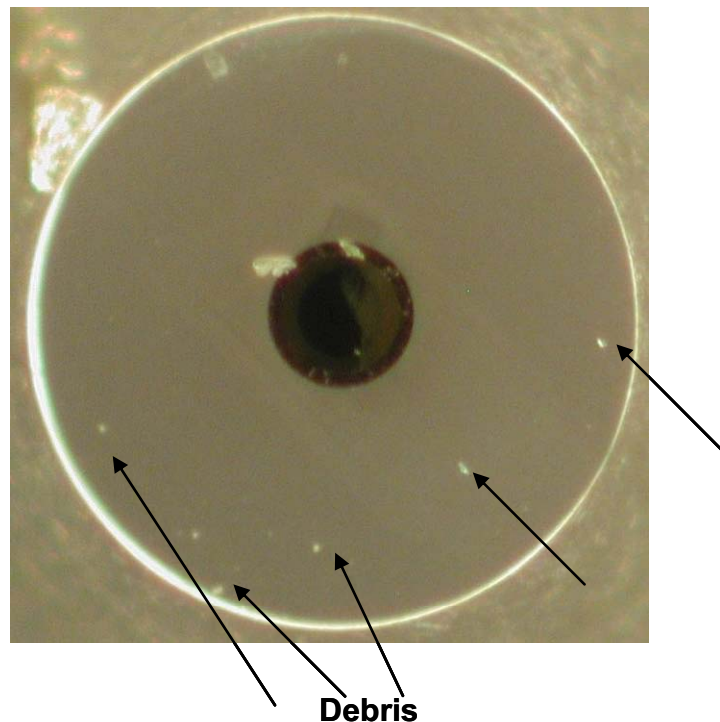
Figure 7.8-2. Optical Image at Magnification of 40X

At 40X magnification (Figure 7.8-2), debris can be seen in several areas in and around the fiber. There also appears to be a smudge over the core. When a defect cannot be removed by means of cleaning, it must be observed at higher magnifications.

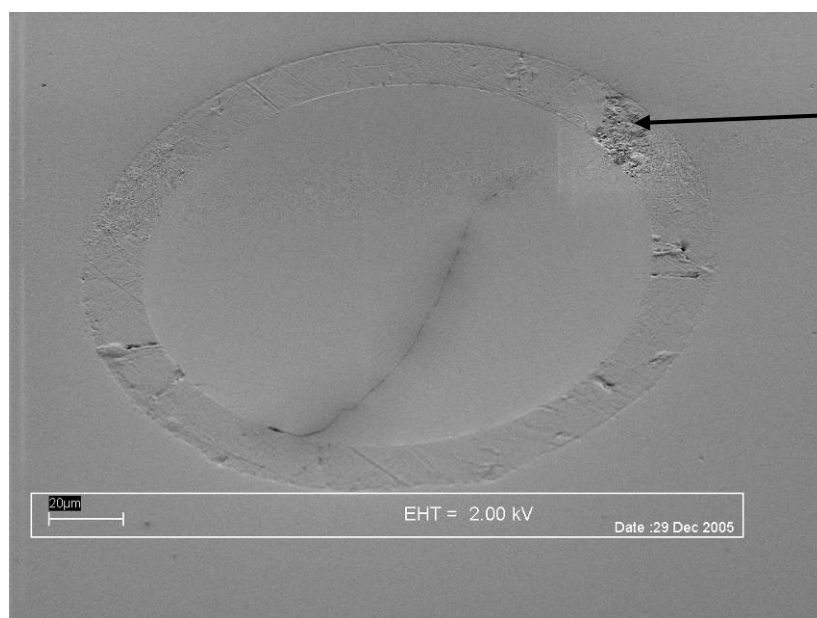
Figure 7.8-6. Clear View of Crack

SEM was performed (Figure 7.8-6), which enabled the crack to be clearly observed.

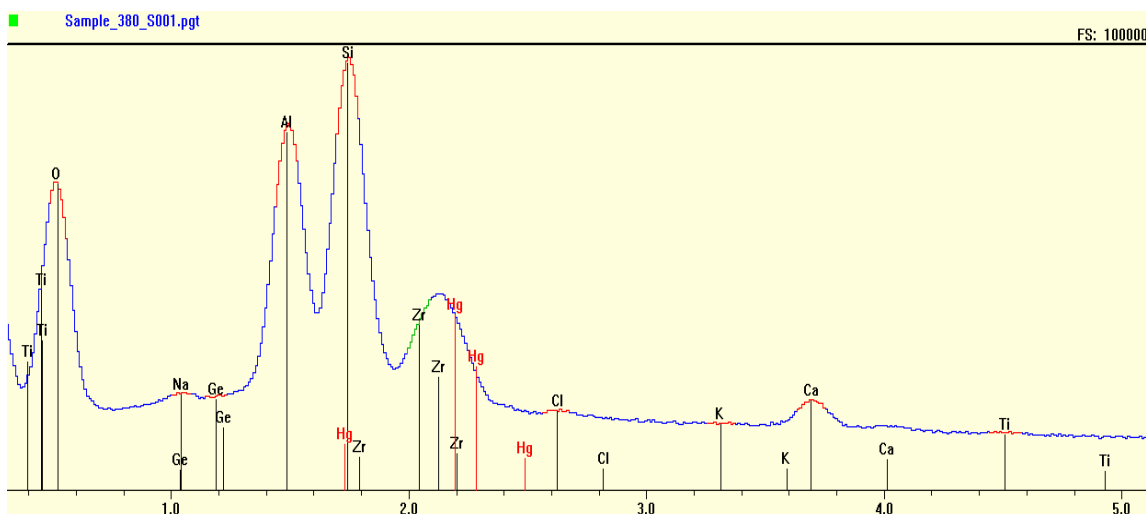
Figure 7.8-8. EDS Data

An EDS data analysis (Figure 7.8-8) of the corrosive area indicates the presence of Na and Cl.
